SUMMER 2019

75 YEARS  
**Spicer**  
group

# NEW DOCK STRUCTURE ADAPTS TO UNPREDICTABLE GREAT LAKES

## CITY OF MANISTEE DOCKS

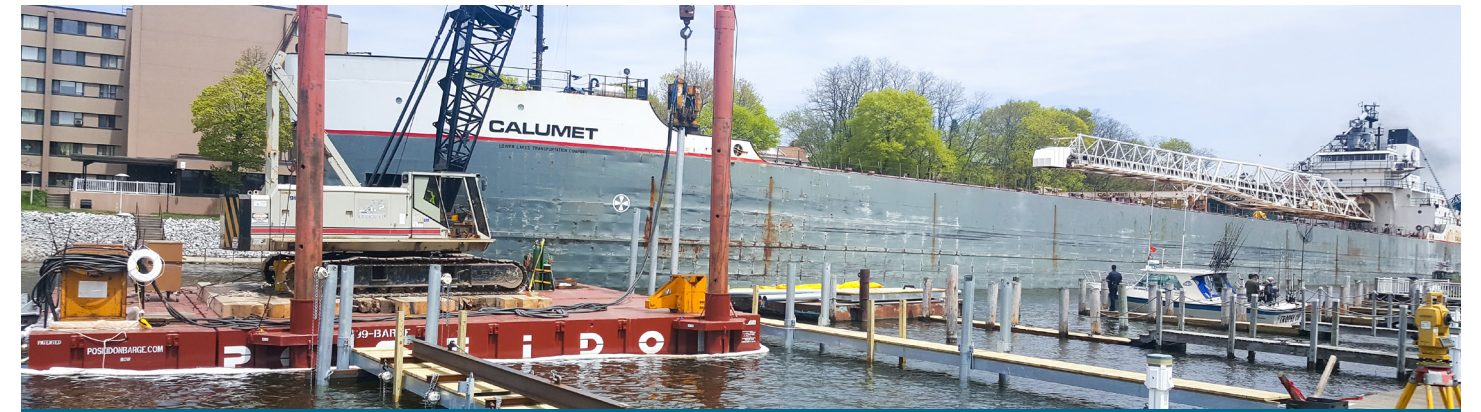
Freighter coming through the Manistee River during construction.

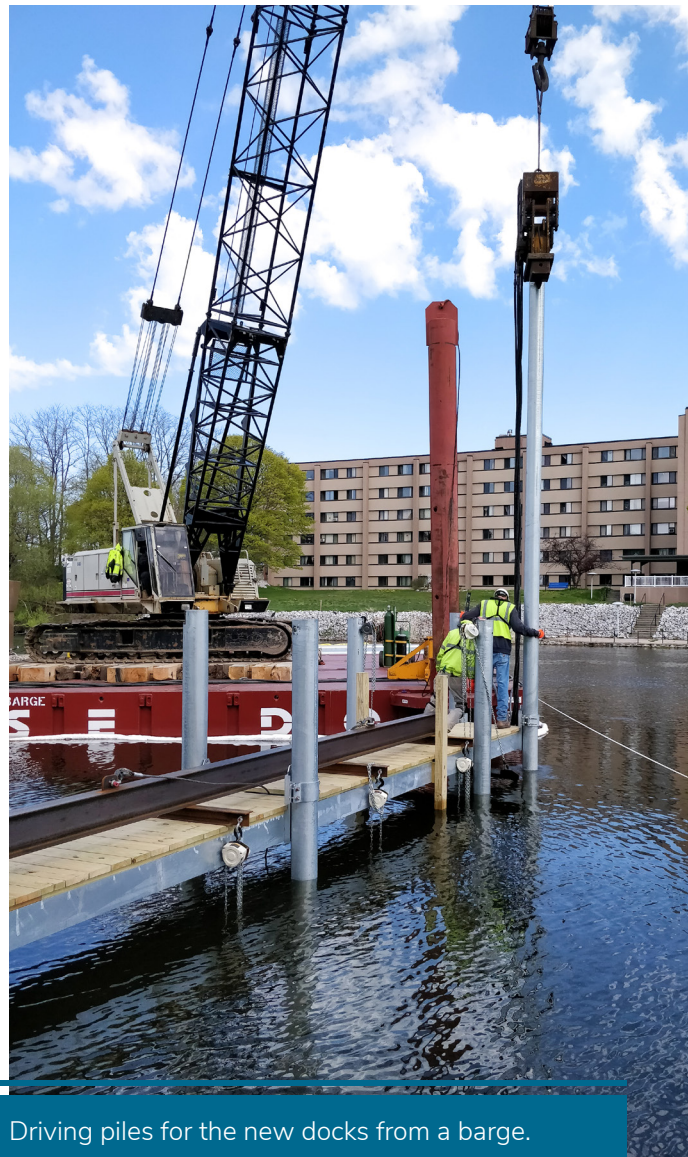
Driving piles for the new docks from a barge.

The team designed a dock system that included the use of eight-inch-diameter galvanized steel pilings up to 45 feet long. Using a large crane on a barge, the pilings were mechanically vibrated up to 20 feet deep into the river bottom depending on location. Twenty-foot sections of dock made of galvanized steel stringers and timber decking were then attached to the pilings using custom-designed clamps.

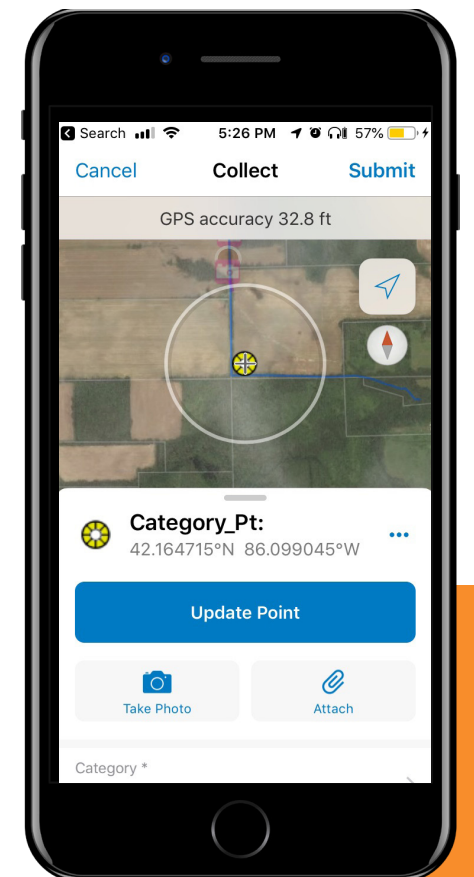
Collector being used on a phone for drain inspection.

The Drain Office's task of performing drain inspections has been updated so that photos and locations are no longer manually produced from separate files. This was accomplished by assigning route identification numbers to all the county drain GIS features and publishing a new set of GIS layers to record locations and photos of obstructions, debris, and erosion. The inspection layers are collected using iPads in the field with ArcGIS Collector. After the inspection points and photos are collected, the drain inspection's points can be summarized in a drain inspection PDF using an ArcGIS Online Web App specifically set up to report on drains. This report includes a map portion illustrating the photo locations and a corresponding photo report sorted by station.

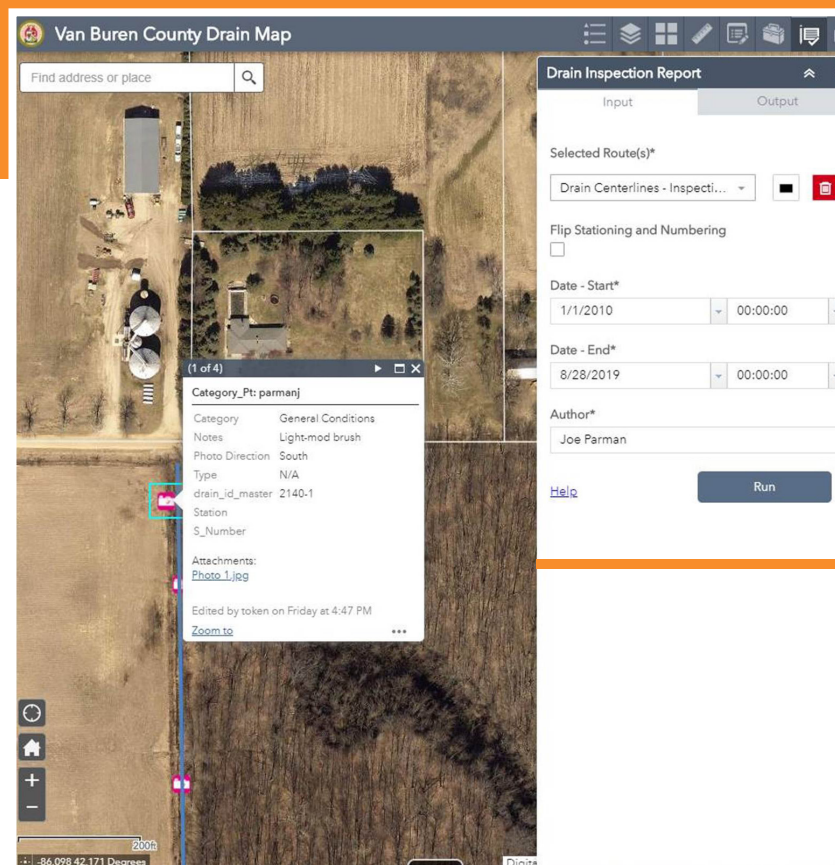
Inspection points collected in the field are easily reviewed and summarized through a web app.
